**ASTM E 90 SOUND TRANSMISSION LOSS  
TEST REPORT**

**COEUR D'ALENE WINDOW**

**SERIES/MODEL: 3121**

**TYPE: Horizontal Sliding Window**

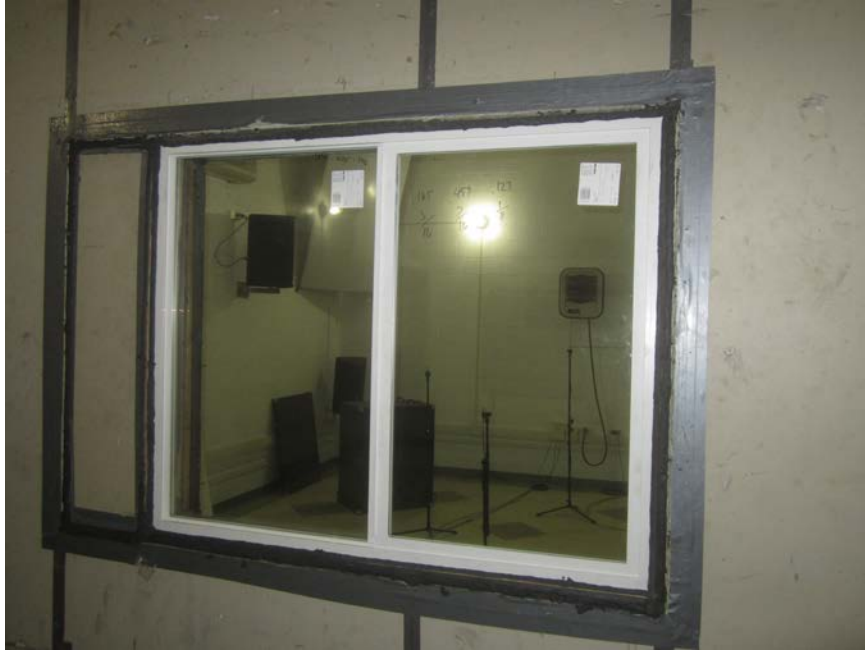
**Receive Room View of Installed Specimen**

**Sample Installation:** A double stud filler wall was constructed with 2-1/2" steel studs and 3-1/2" steel studs spaced 24" on center. Five layers of 5/8" Type "X" gypsum board were fastened to the receive side of the filler wall. Three layers of 1/2" cement board were fastened to the source side of the filler wall. The cavity was filled with two layers of R-13 fiberglass insulation. The perimeter and seams were sealed with acoustical sealant. A sound transmission loss test was then conducted on the filler wall. The filler wall achieved an STC rating of 71. The 60-1/2" by 48-1/2" filler wall plug was removed.

A filler wall-reducing element was built to adjust the test opening size to accommodate the test specimen. The reducing element consisted of a double 2x4 wood stud wall construction with three layers of 5/8" drywall on both sides. The stud cavities in the wall were insulated with two layers of R-13 fiberglass insulation. The window system was placed on isolation pads in the test opening. Duct seal was used to seal the perimeter of the test specimen to the test opening on both sides. The interior side of the test specimen, when installed, was approximately 1/4" from being flush with the receiving room side of the filler wall. A stethoscope was used to check for any abnormal air leaks around the test specimen prior to testing. The sash was opened and closed at least five times prior to testing.

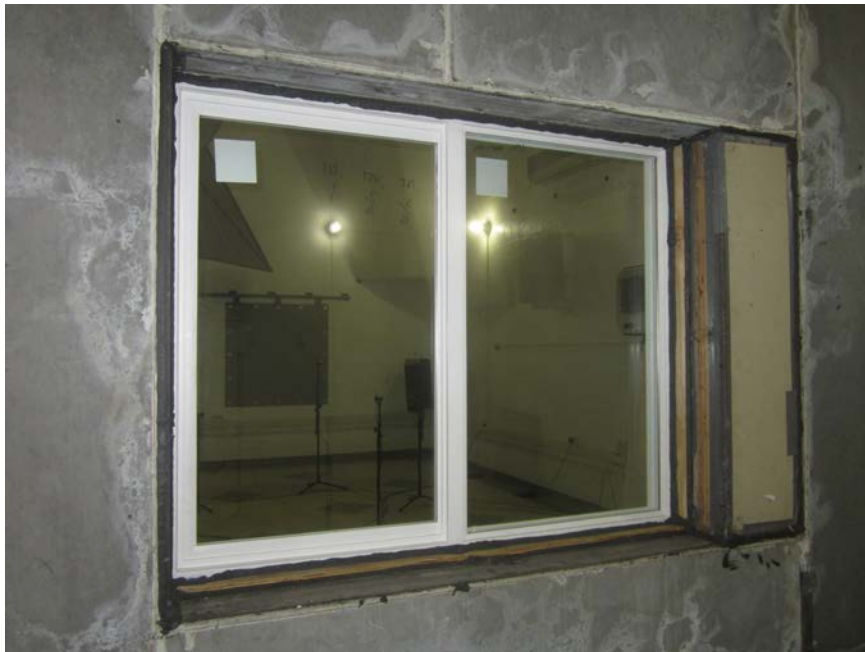
**Source Room View of Installed Specimen**
