**ASTM E 90 SOUND TRANSMISSION LOSS  
TEST REPORT**

**COEUR D'ALENE WINDOW**

**SERIES/MODEL: 3221**

**TYPE: Single Hung Window**

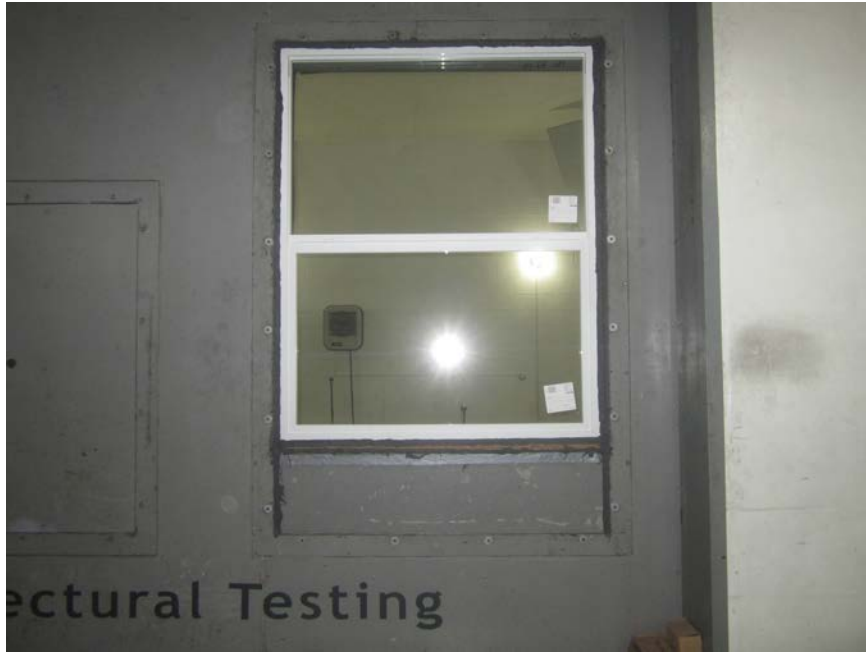
**Receive Room View of Installed Specimen**

A filler wall-reducing element was used to adjust the test opening size. The reducing element consisted of two separate 2x6 wood frames filled with concrete to reduce the test opening size to accommodate the test specimen. A dense neoprene gasket was placed between the two wood and concrete frames. The window was placed on an isolation pad in the new test opening. Duct seal was used to seal the perimeter of the window to the test opening on both sides. The interior side of the window frame, when installed, was approximately 1/4" from being flush with the receiving room side of the filler wall. A stethoscope was used to check for any abnormal air leaks around the test specimen prior to testing. The sash was opened and closed at least five times prior to testing.

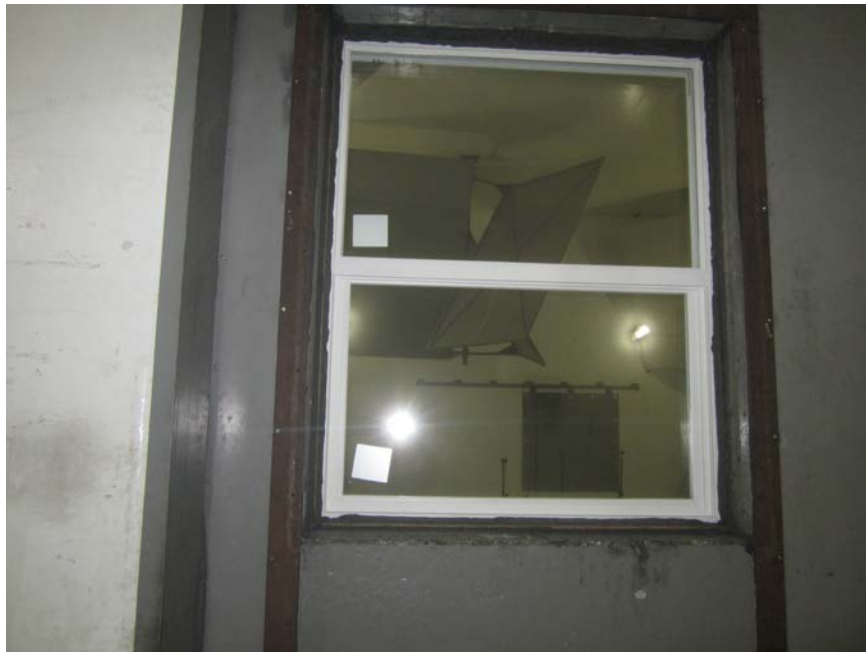
**Source Room View of Installed Specimen**
