**ASTM E 90 SOUND TRANSMISSION LOSS
TEST REPORT**

COEUR D'ALENE WINDOW

SERIES/MODEL: 3310

Report No: E2101.01-113-11
Test Date: 11/19/14
Report Date: 12/18/14

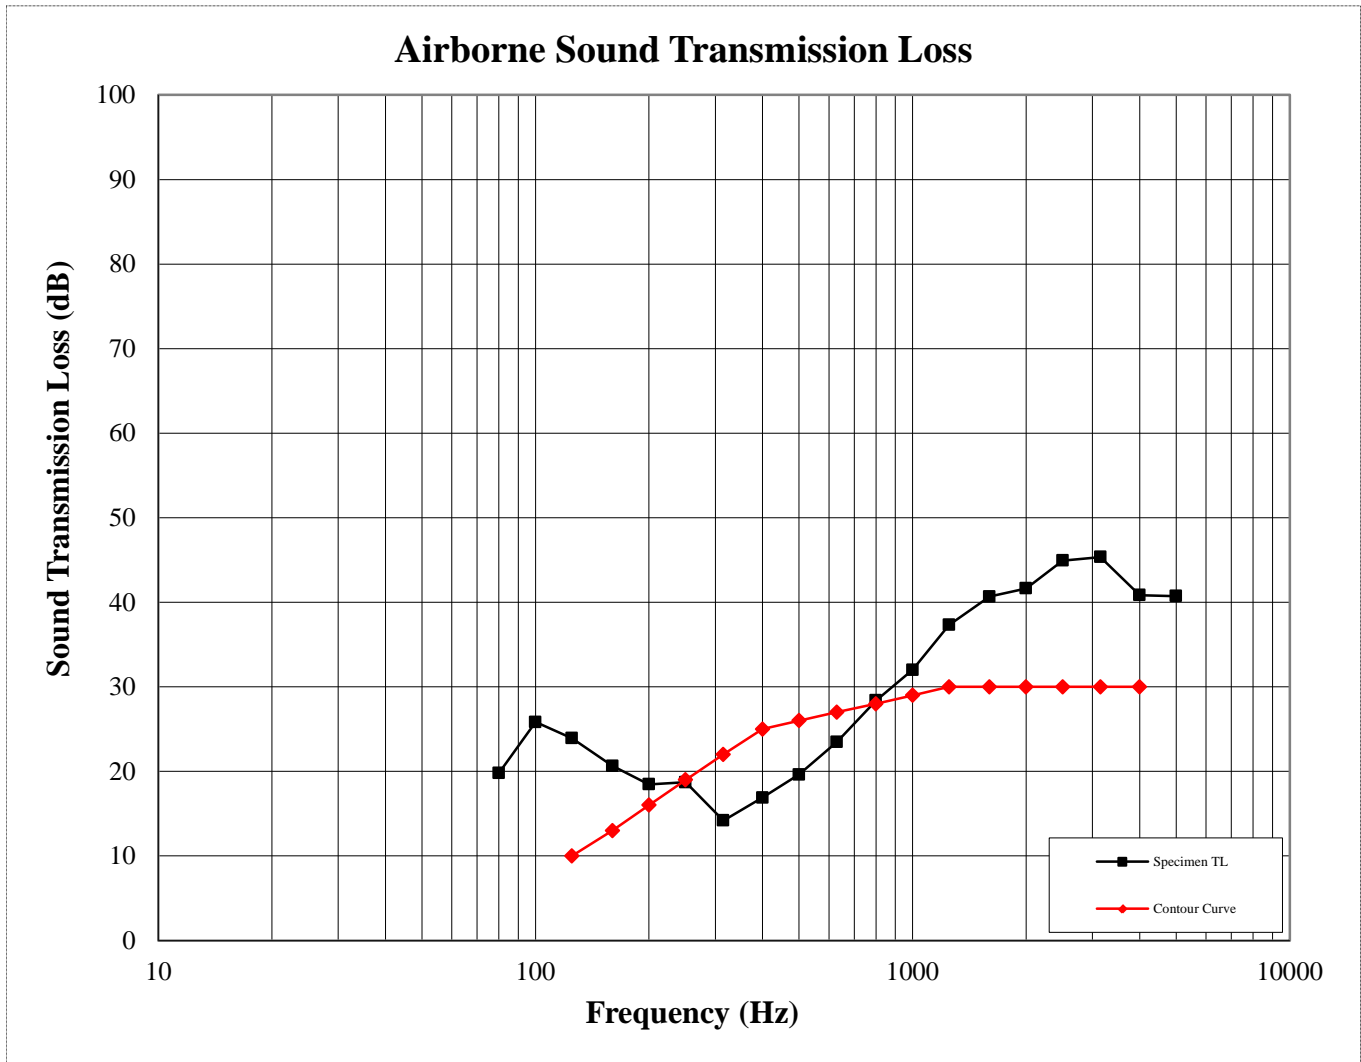
| Data File No. | E2101.01A |

STC Rating **26** *(Sound Transmission Class)*
Deficiencies **26** *(Sum of Deficiencies)*
OITC Rating **22** *(Outdoor-Indoor Transmission Class)*

| Description | Series/Model: 3310, Picture window with 13/16" IG (3/32" annealed exterior, 19/32" air space, 1/8" annealed interior) |

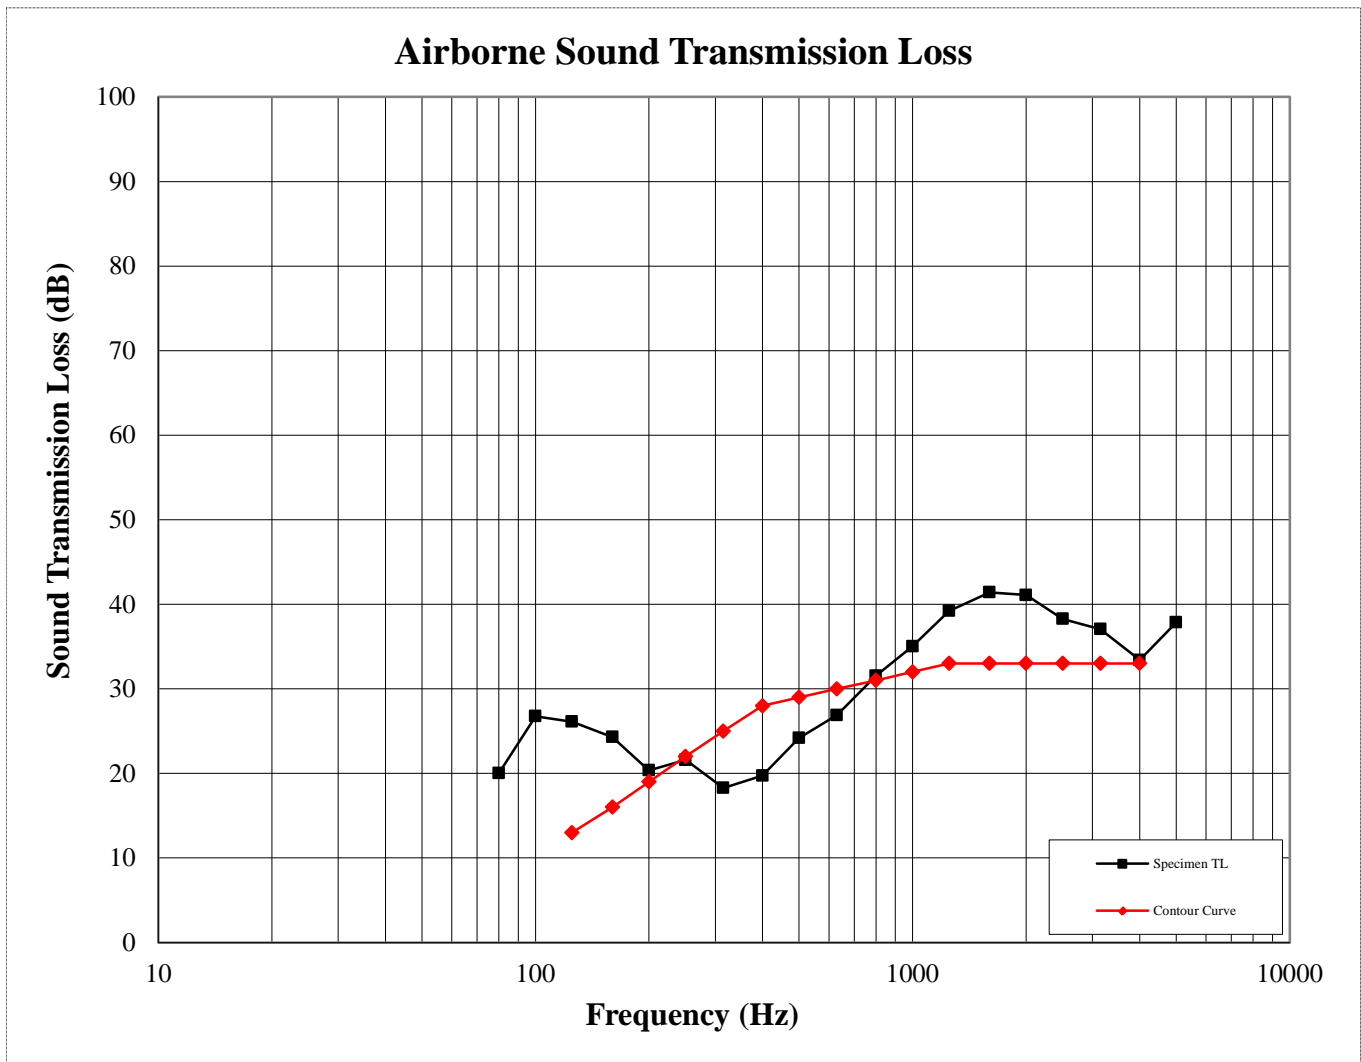
| Data File No. | E2101.01B |

STC Rating **29** *(Sound Transmission Class)*
Deficiencies **23** *(Sum of Deficiencies)*
OITC Rating **25** *(Outdoor-Indoor Transmission Class)*

| Description | Series/Model: 3310, Picture window with 3/4" IG (1/8" annealed exterior, 7/16" air space, 3/16" annealed interior) |

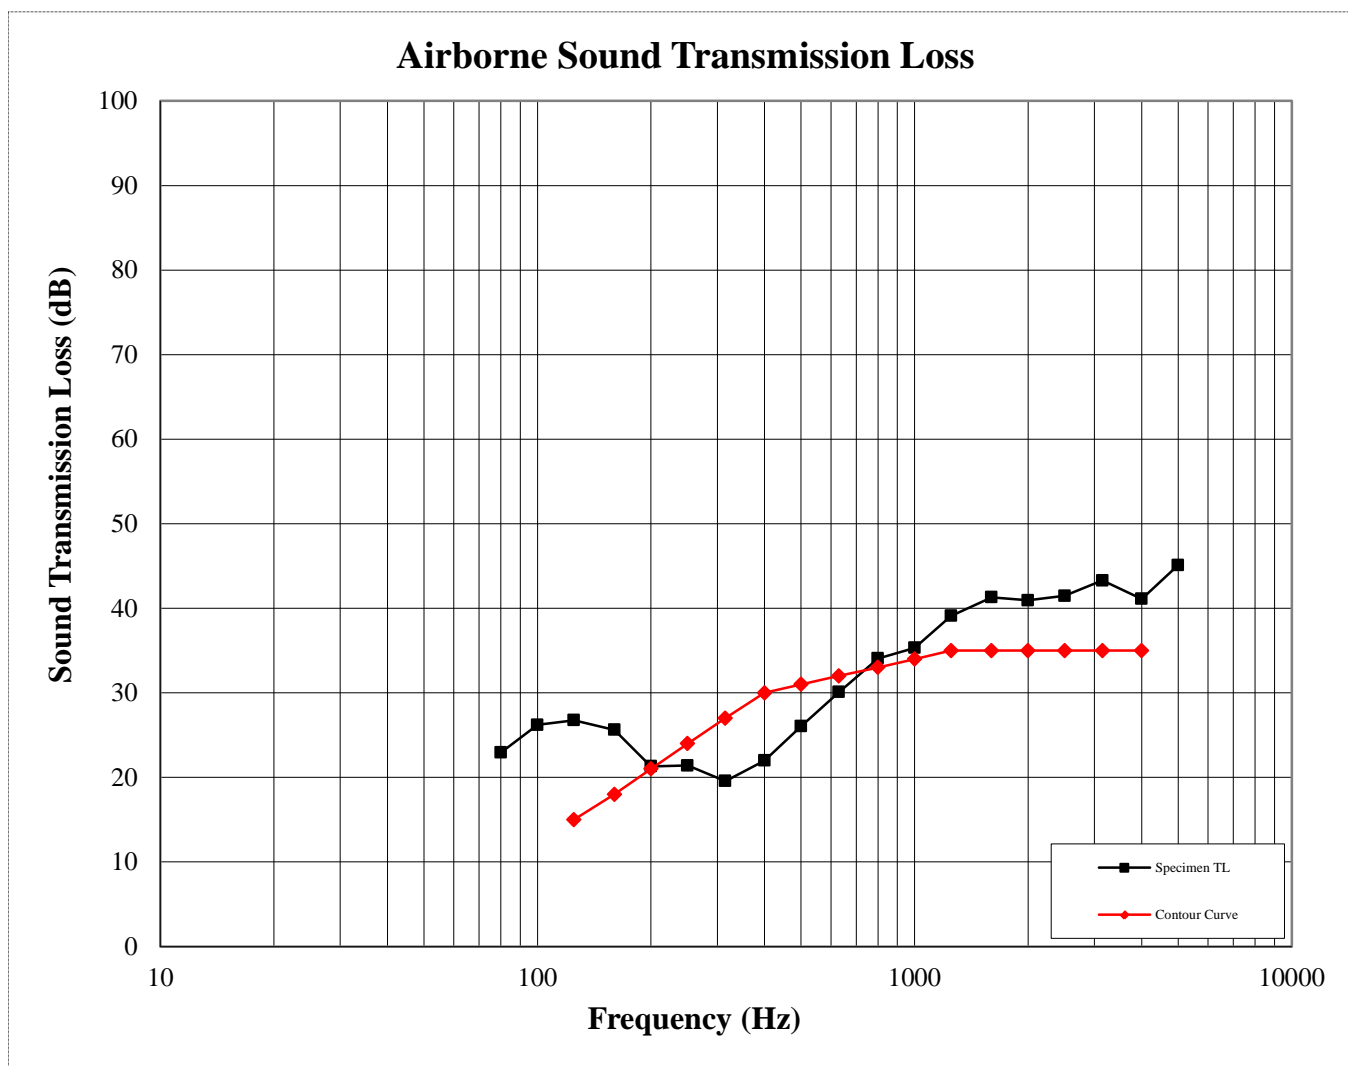
| Data File No. | E2101.01C |

STC Rating **31** *(Sound Transmission Class)*
Deficiencies **25** *(Sum of Deficiencies)*
OITC Rating **27** *(Outdoor-Indoor Transmission Class)*

| Description | Series/Model: 3310, Picture window with 3/4" IG (1/8" annealed exterior, 3/8" air space, 1/4" laminated interior), Glass temperature 75°F |

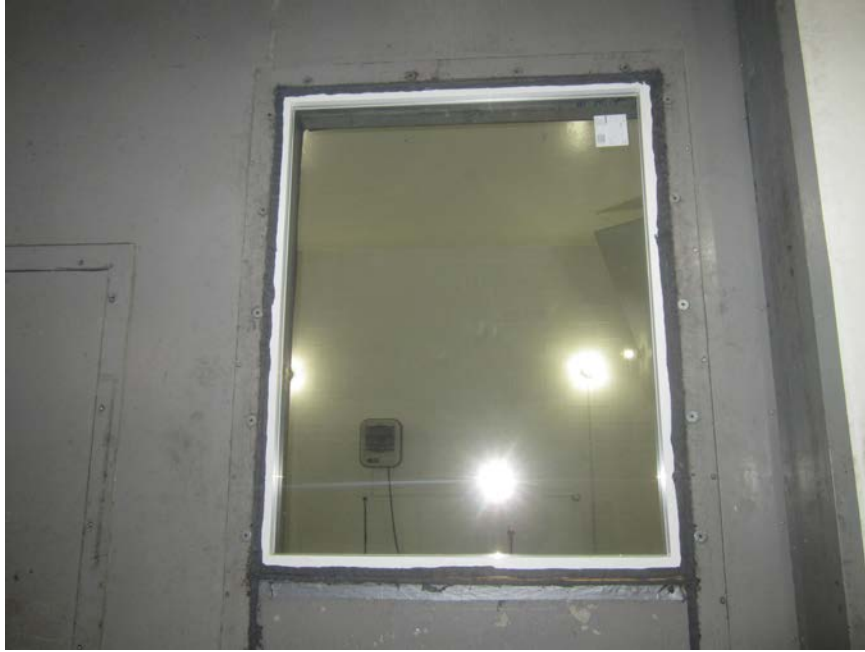
Receive Room View of Installed Specimen

A filler wall-reducing element was used to adjust the test opening size. The reducing element consisted of two separate 2x6 wood frames filled with concrete to reduce the test opening size to accommodate to test specimen. A dense neoprene gasket was placed between the two wood and concrete frames. The window was placed on an isolation pad in the new test opening. Duct seal was used to seal the perimeter of the window to the test opening on both sides. The interior side of the window frame, when installed, was approximately 1/4" from being flush with the receiving room side of the filler wall. A stethoscope was used to check for any abnormal air leaks around the test specimen prior to testing.

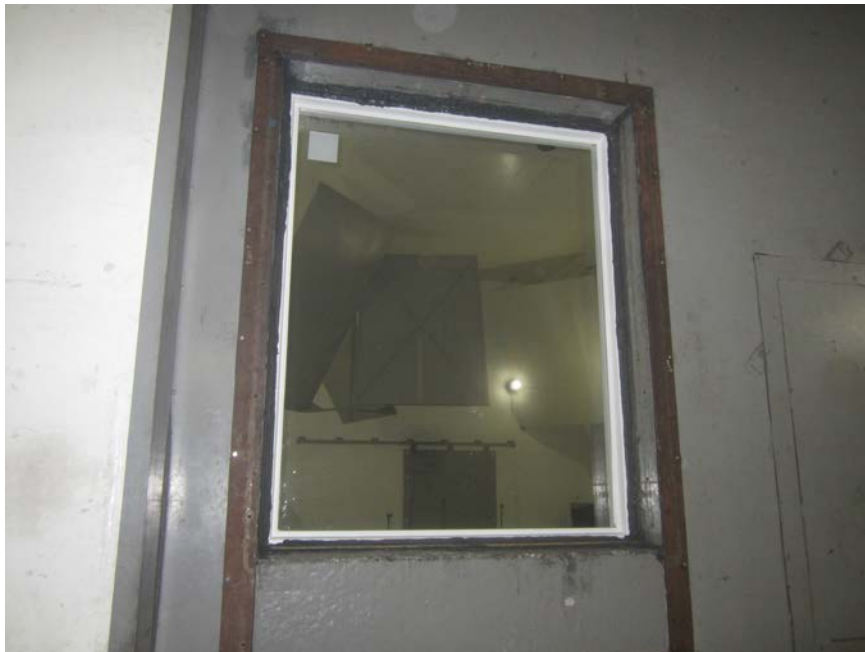
Source Room View of Installed Specimen
